STORMWATER FACILITY MAINTENANCE MANUAL

**Clark County Public Works Department
Clean Water Program**

January 2008

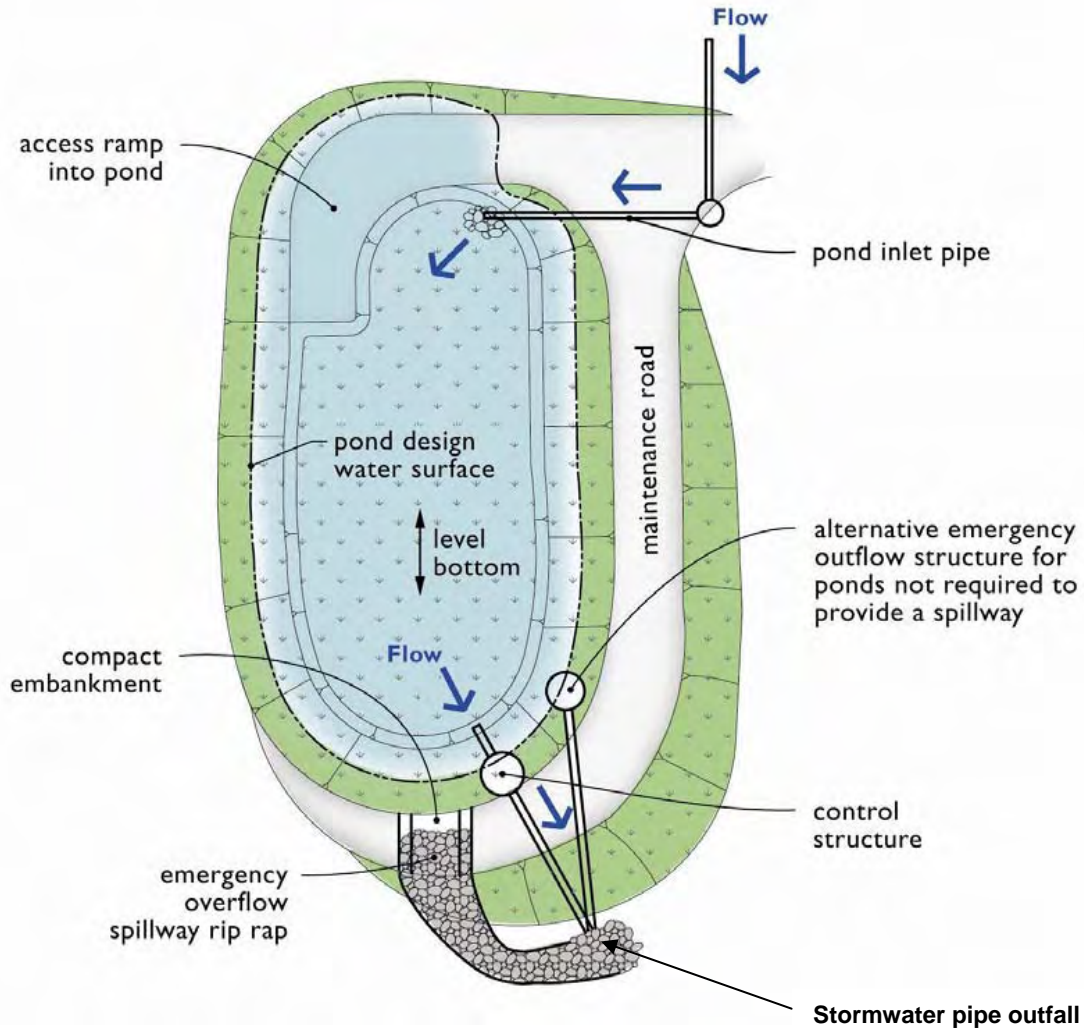
Facility objects that are typically associated with a detention pond include:

- access road or easement
- fence, gate, and water quality sign
- control structure/flow restrictor
- energy dissipaters
- debris barrier (e.g. trash rack)
- inlet/outlet stormwater pipe

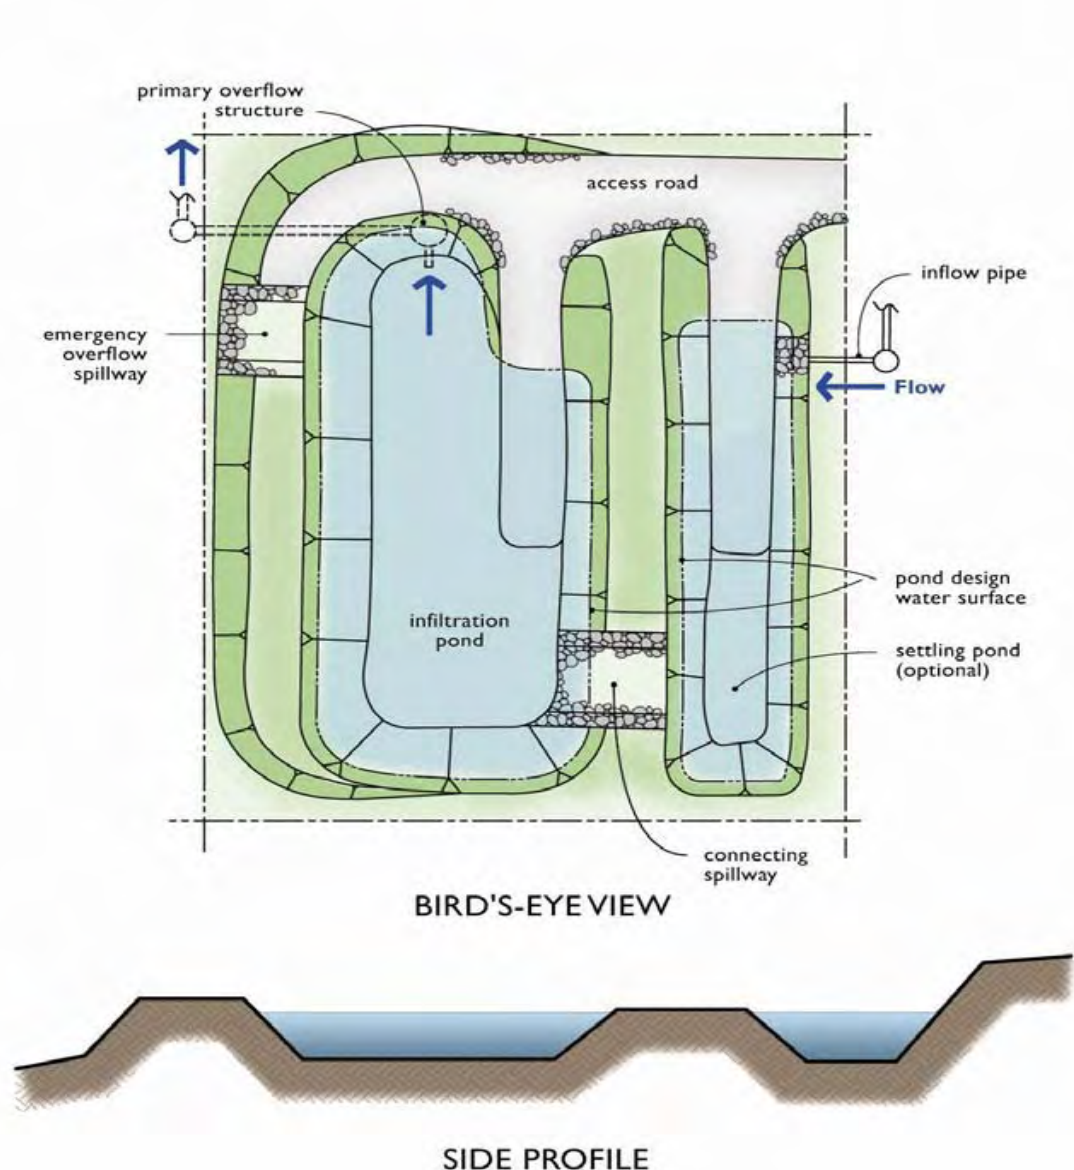
A stormwater infiltration open basin disposes of water by holding it in an area where it can soak into the ground. These are open facilities that may either drain rapidly and have grass bases, or have perpetual ponds where water levels rise and fall with stormwater flows. Infiltration facilities may be designed to handle all of the runoff from an area or they may overflow and bypass larger storms. Since the facility is design to pass water into the ground, anything that can cause the base to clog will reduce performance and is a large concern. Generally, infiltration basins are managed like detention ponds but with greater emphasis on maintaining the capacity to infiltrate stormwater.

Facility objects that are typically associated with an infiltration facility include:

- access road or easement
- fence, gate, and water quality sign
- energy dissipaters
- debris barrier (e.g. trash rack)
- inlet/outlet stormwater pipe

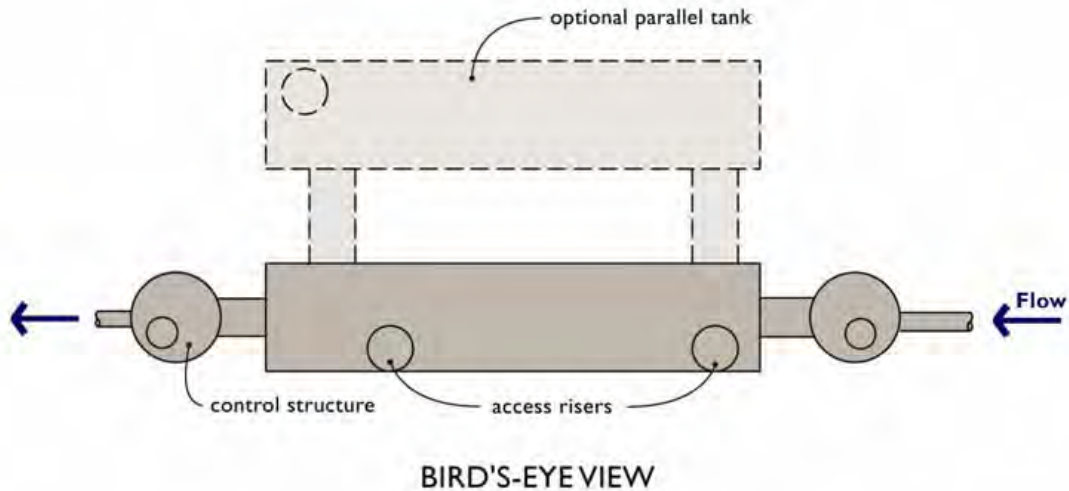
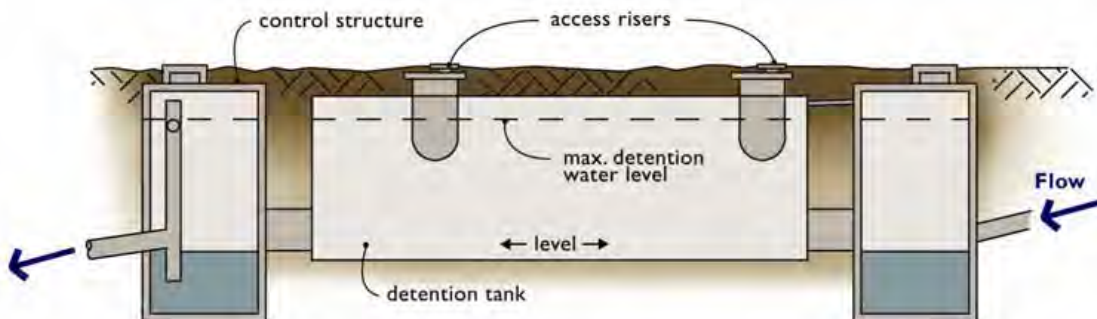
SIDE PROFILE

Underground detention systems are enclosed spaces where harmful chemicals and vapors can accumulate. Therefore, the inspection and maintenance of these facilities should be conducted by an individual trained and certified to work in hazardous confined spaces.

Note:
Closed detention systems will contain water during rainfall events, but should be empty during dry periods.

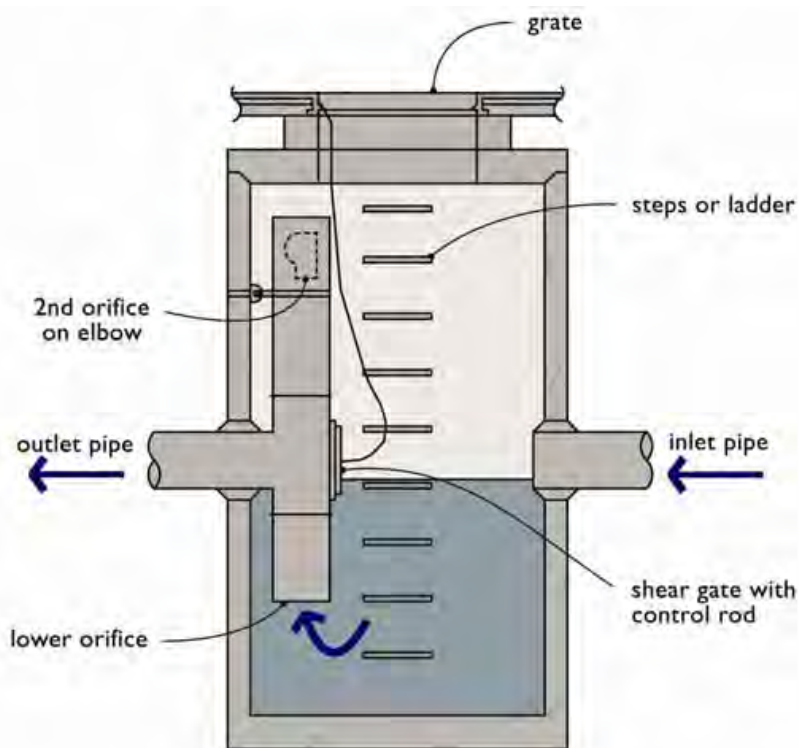
BIRD'S-EYE VIEW

Flow control structures and flow restrictors direct or restrict flow in or out of facility components. Outflow controls on detention facilities are a common example where flow control structures slowly release stormwater at a specific rate. The flow is regulated by a combination of orifices (holes with specifically sized diameters) and weirs (plates with rectangular or "V" shaped notch). Lack of maintenance of the control structure can result in the plugging of an orifice. If these flow controls are damaged, plugged, bypassed, or not working properly, the facility could overtop or release water too quickly. This will likely damage streams, habitat, and property.

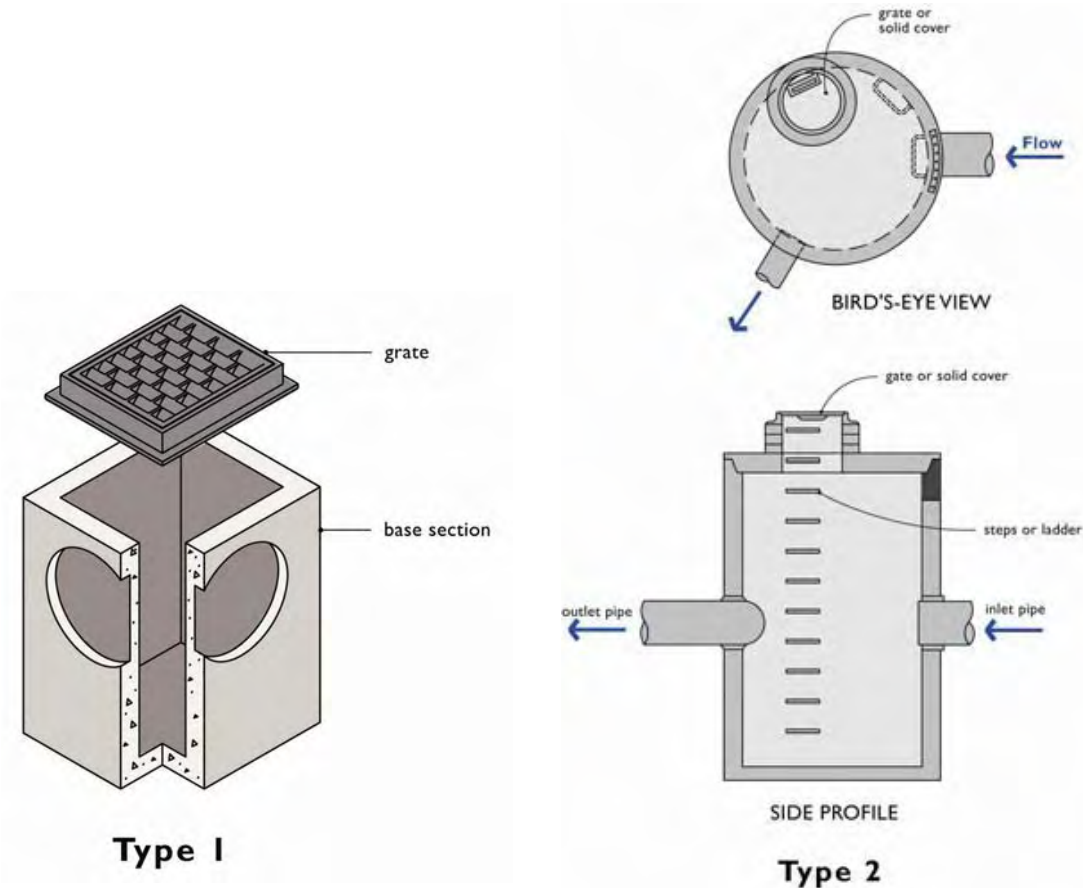
Both types typically provide a storage volume (sump) below the outlet pipe to allow sediments and debris to settle out of the stormwater runoff. Some catch basins are also fitted with a spill control device (inverted elbow on outlet pipe) intended to contain large quantities of grease or oils.

The most common tool for cleaning catch basins is a truck with a tank and vacuum hose (vector truck) to remove sediment and debris from the sump. A catch basin may be an enclosed space where harmful chemicals and vapors can accumulate. Therefore, if the inspection and maintenance requires entering a catch basin, it should be conducted by an individual trained and certified to work in hazardous confined spaces.

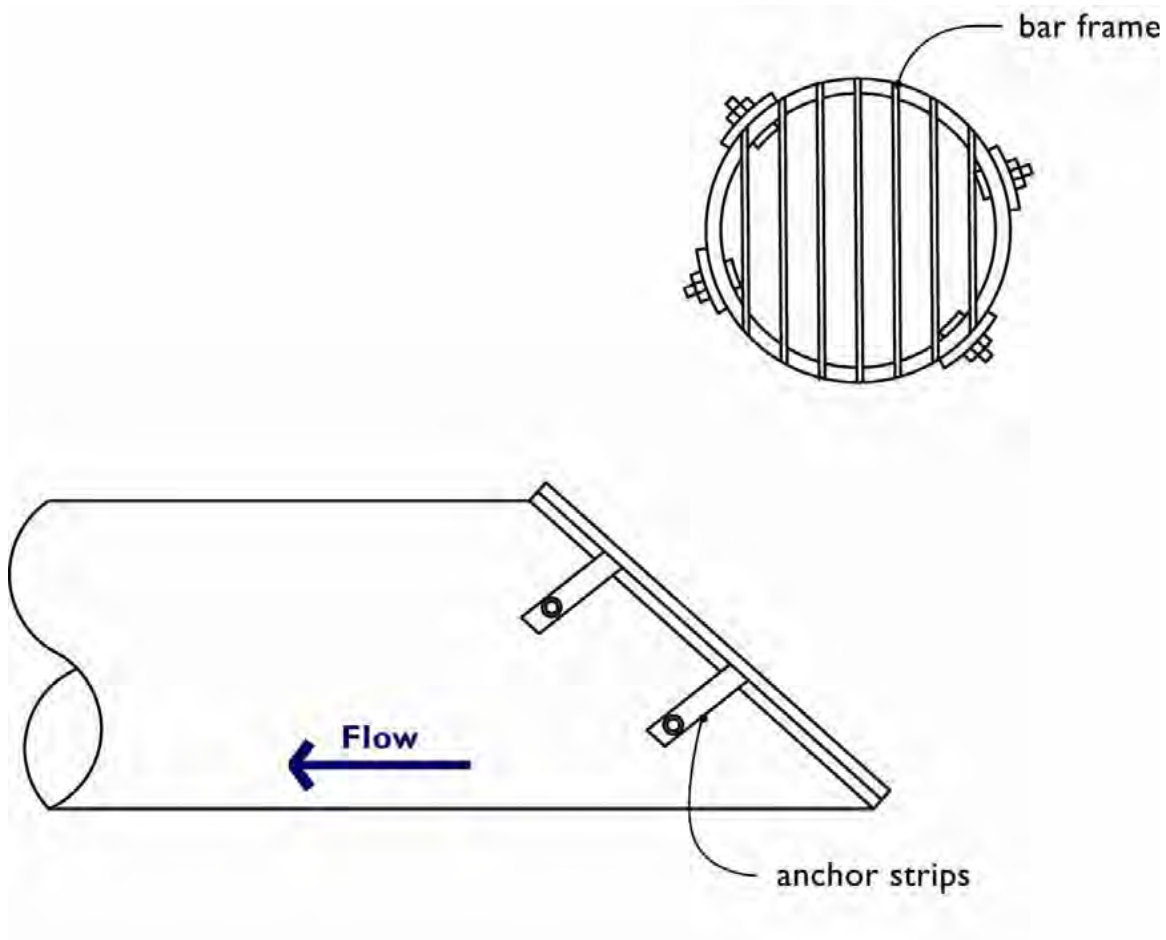
A debris barrier is a bar grate over the open end of a culvert or stormwater conveyance pipe. The intent of a debris barrier is to prevent large materials from entering a closed pipe system. Debris barriers are typically located on the outlet pipe from a detention pond to the control structure. If a debris barrier is not located on the outlet pipe, one should be installed to prevent plugging of the control structure and possible flooding.

An access barrier is similar to a debris barrier but is installed on all pipe ends that exceed 18 inches in diameter. Their function is to prevent debris and unauthorized access into the storm conveyance pipe. Only qualified personnel should attempt to maintain or remove debris from the barrier when water is flowing through the conveyance pipe.

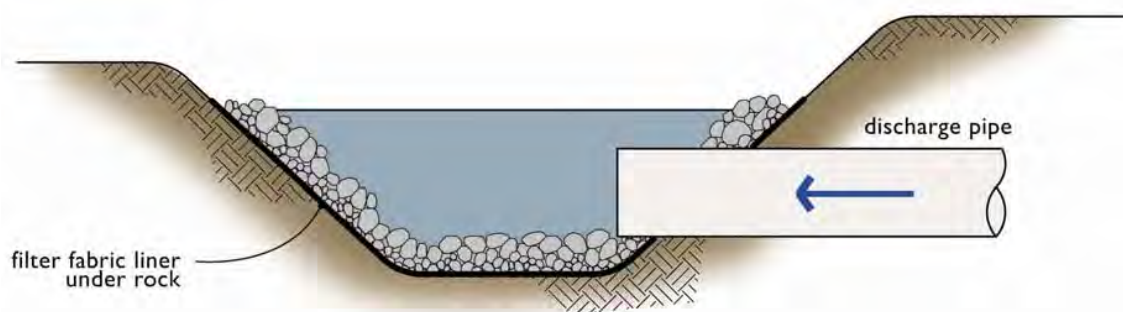
An energy dissipater is installed on or near the inlet or outlet to a closed pipe system to prevent erosion at these locations. There are a variety of designs, including wire gabion baskets, rock splash pads, trenches, and specially designed pools or manholes. The rock splash pad is typically constructed of 4- to 12-inch diameter rocks a minimum of 12 inches thick and is often lined with filter fabric. The rock pad should extend above the top of the pipe a minimum of 1 foot.

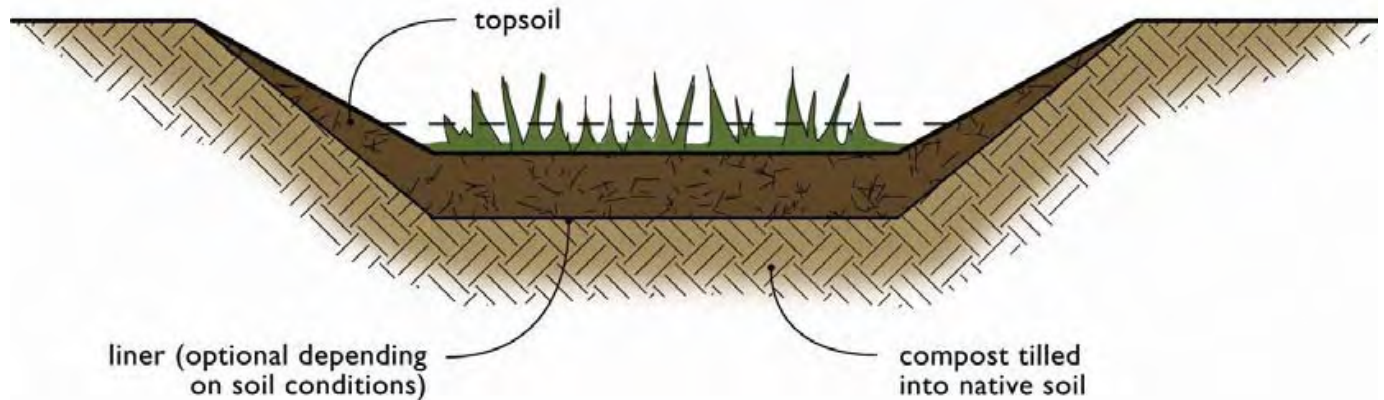
Facility objects that are often associated with a typical biofiltration swale include:

- access road or easement
- fence, gate, and water quality sign
- energy dissipaters
- debris barrier (e.g. trash rack)
- catch basins/field inlets
- drywell
- infiltration trench

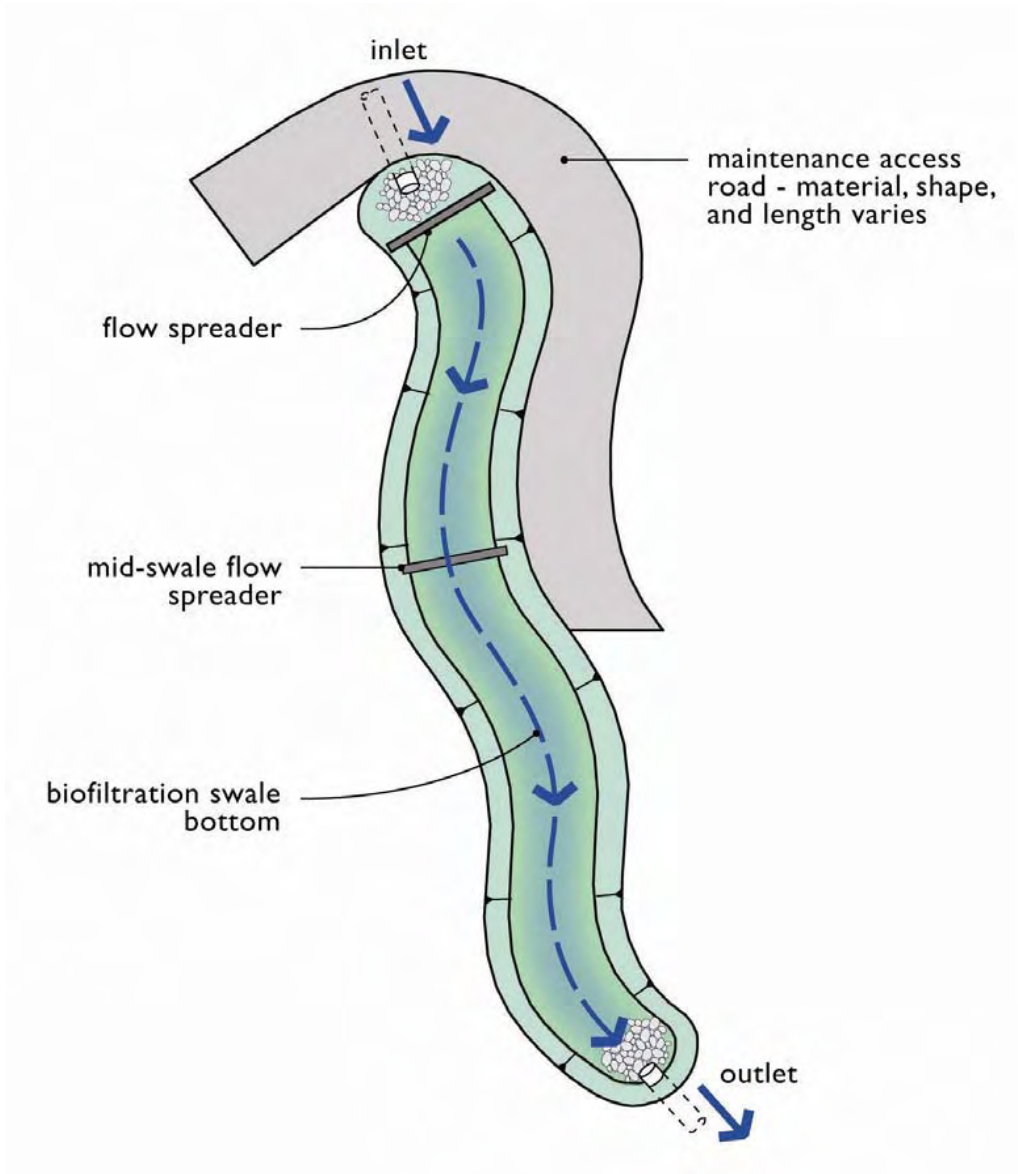
Facility objects that are often associated with a wet biofiltration swale include:

- access road or easement
- fence, gate, and water quality sign
- energy dissipaters (flow spreaders)
- debris barrier (e.g. trash rack)
- catch basins/field inlets

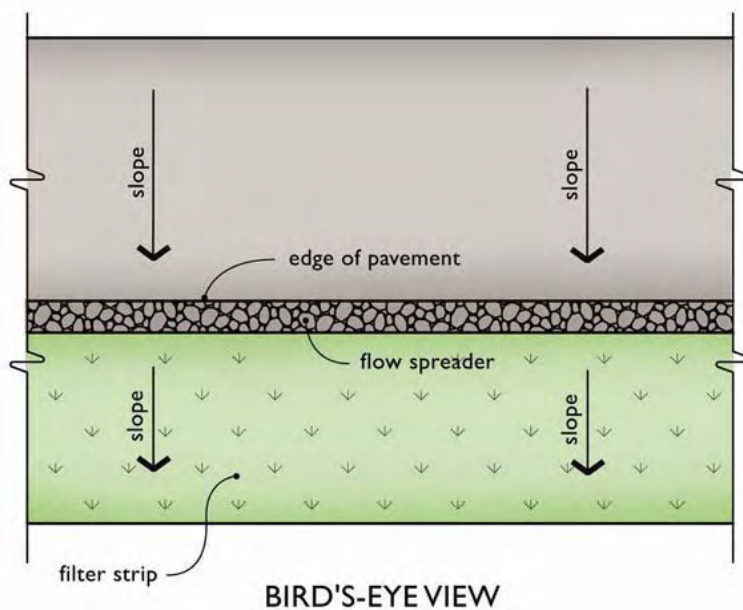
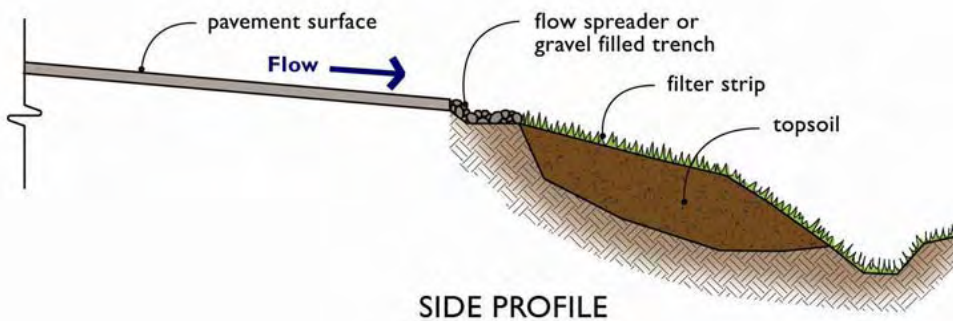
Facility objects that are often associated with a filter strip include:

- access road or easement
- fence, gate, and water quality sign
- energy dissipaters (flow spreaders)

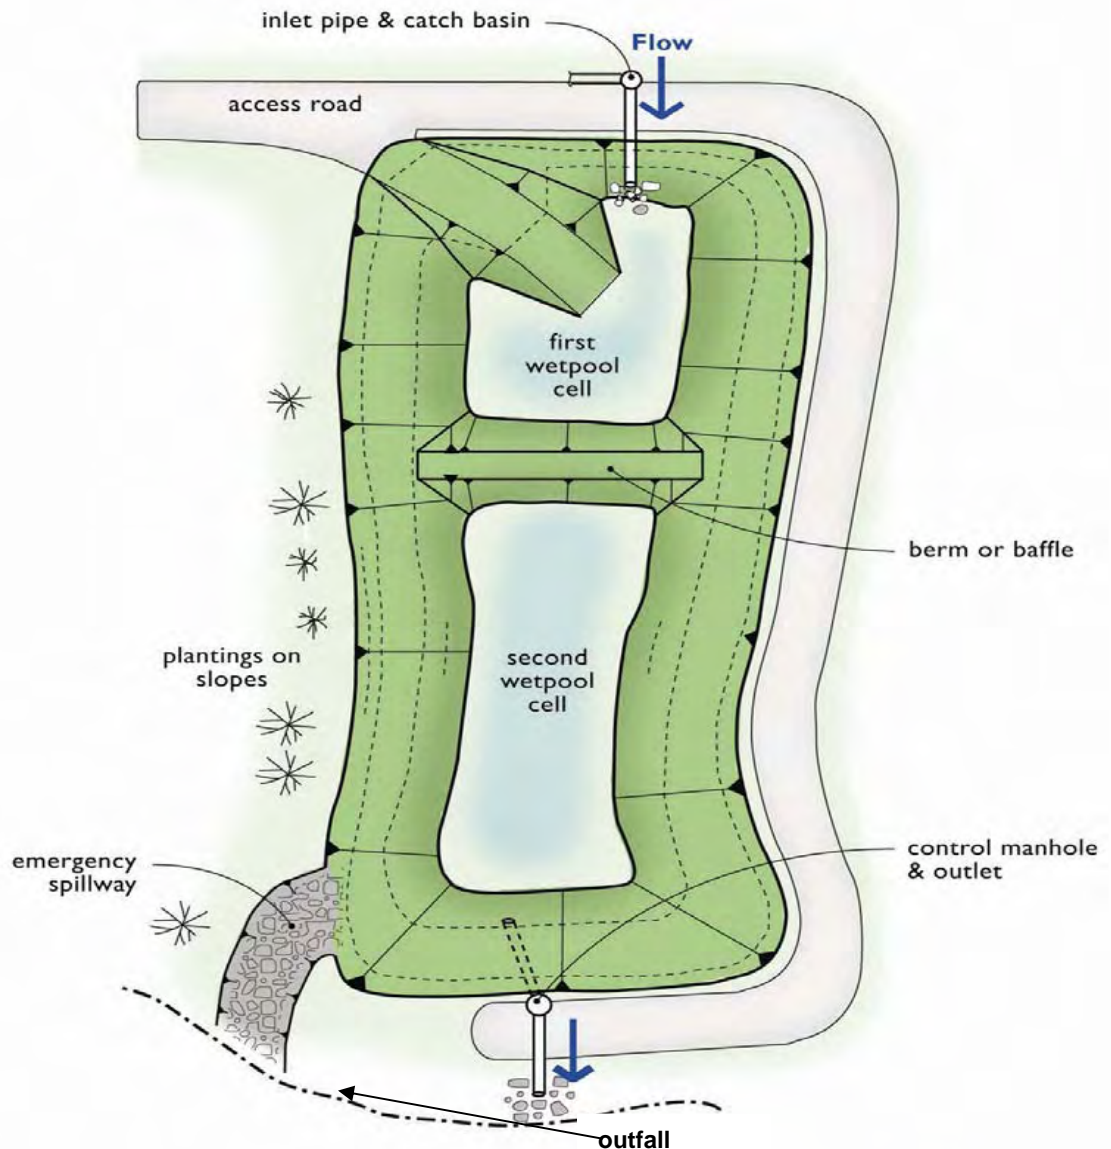
Facility objects that are typically associated with a wetpond include:

- access road or easement
- fence, gate, and water quality sign
- detention pond
- control structure/flow restrictor
- energy dissipaters
- debris barrier (e.g. trash rack)
- inlet/outlet stormwater pipe

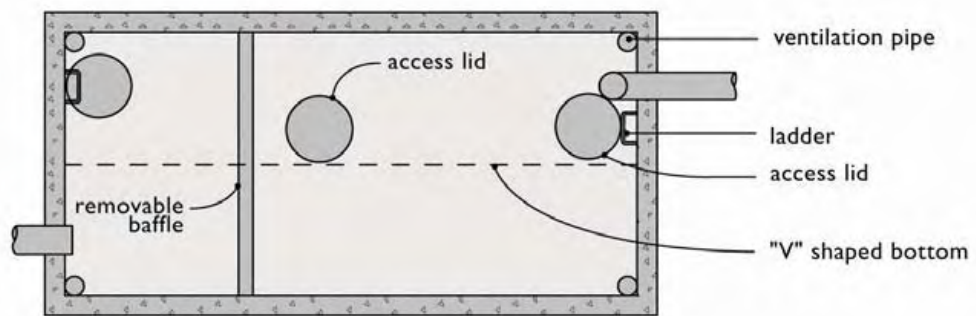
BIRD'S-EYE VIEW

Facility objects that are typically associated with a wet vault include:

- access road or easement
- fence, gate, and water quality sign
- inlet/outlet stormwater pipe

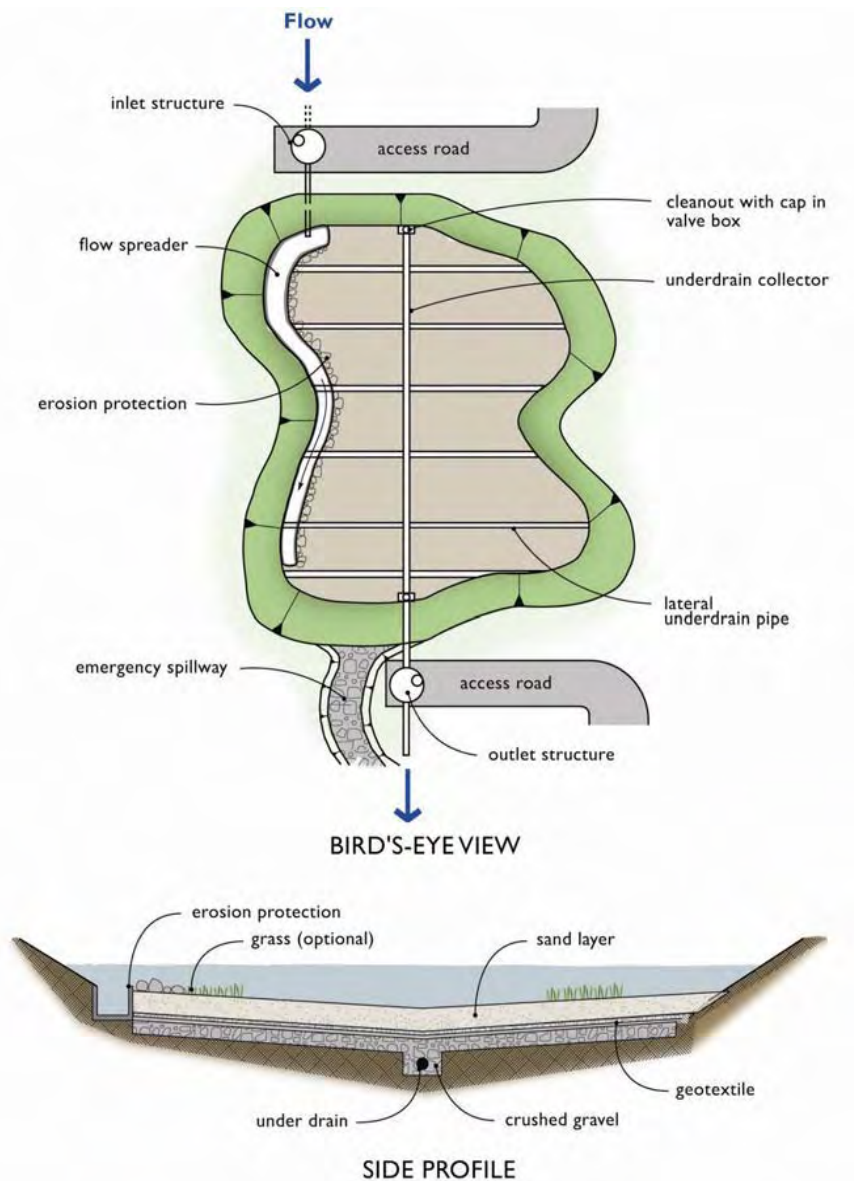
Facility objects that are typically associated with an open sand filter include:

- access road or easement
- fence, gate, and water quality sign
- control structure/flow restrictor
- energy dissipaters
- inlet/outlet stormwater pipe

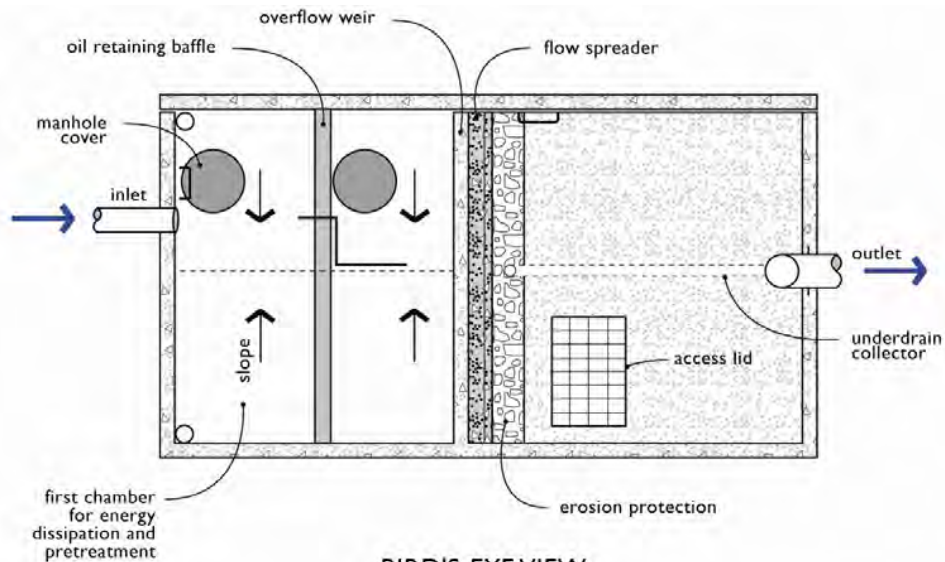
BIRD'S-EYE VIEW

Facility objects that are typically associated with a below ground sand filter include:

- access road or easement
- fence, gate, and water quality sign
- inlet/outlet stormwater pipe

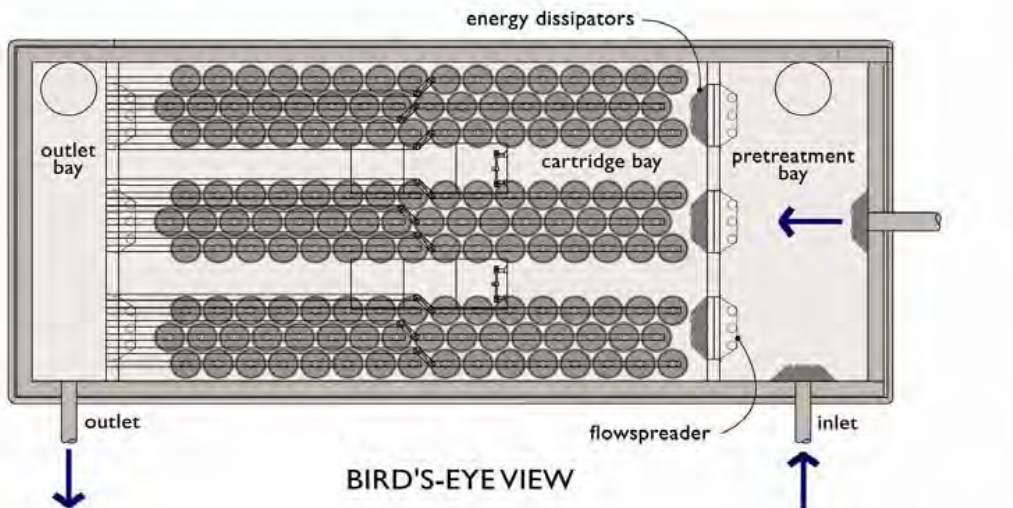
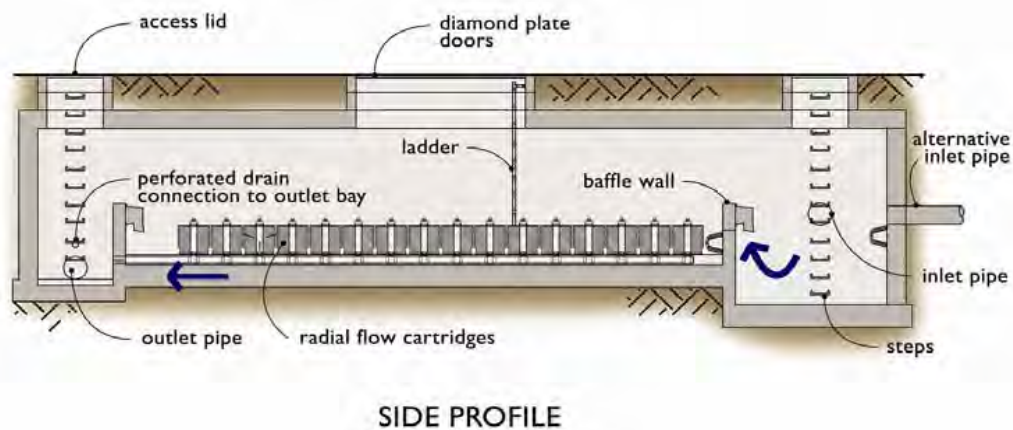
Facility objects that are typically associated with a StormFilter® system include:

- access road or easement
- control structure/flow restrictor
- inlet/outlet stormwater pipe

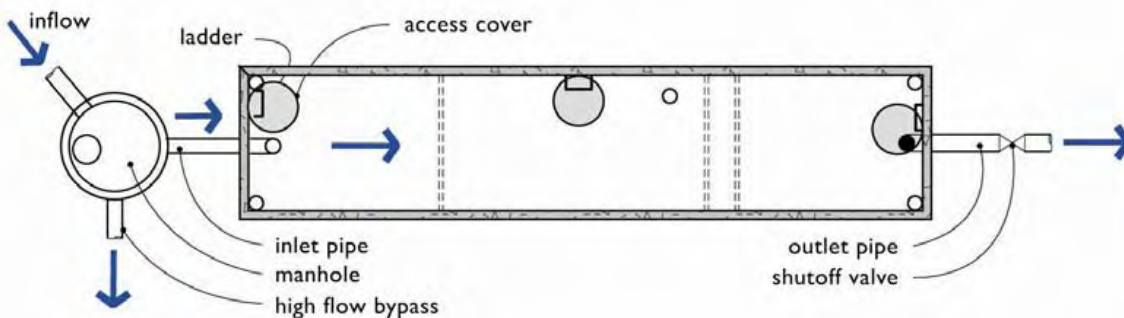
BIRD'S-EYE VIEW

Facility objects that are typically associated with an oil/water separator include:

- access road or easement
- control structure/flow restrictor

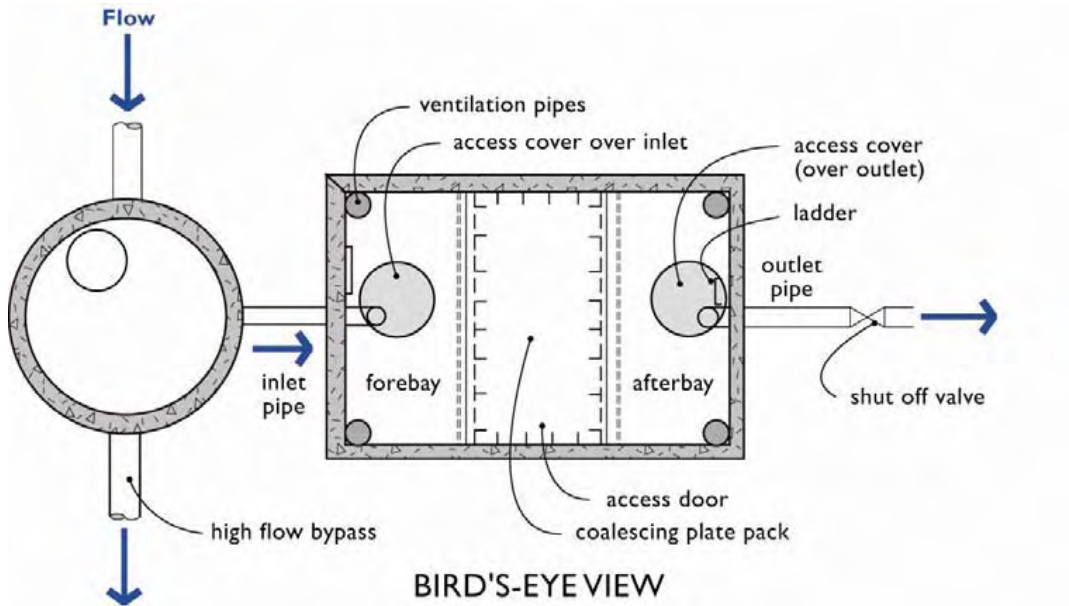
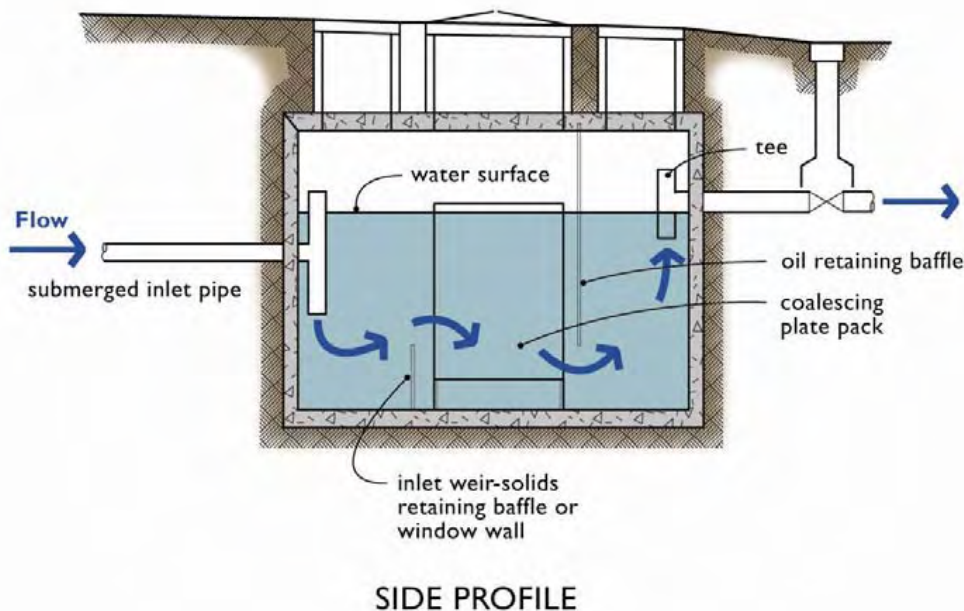
Facility objects associated with a coalescing plate oil/water separator may include:

- access road or easement
- control structure/flow restrictor
- inlet/outlet stormwater pipe

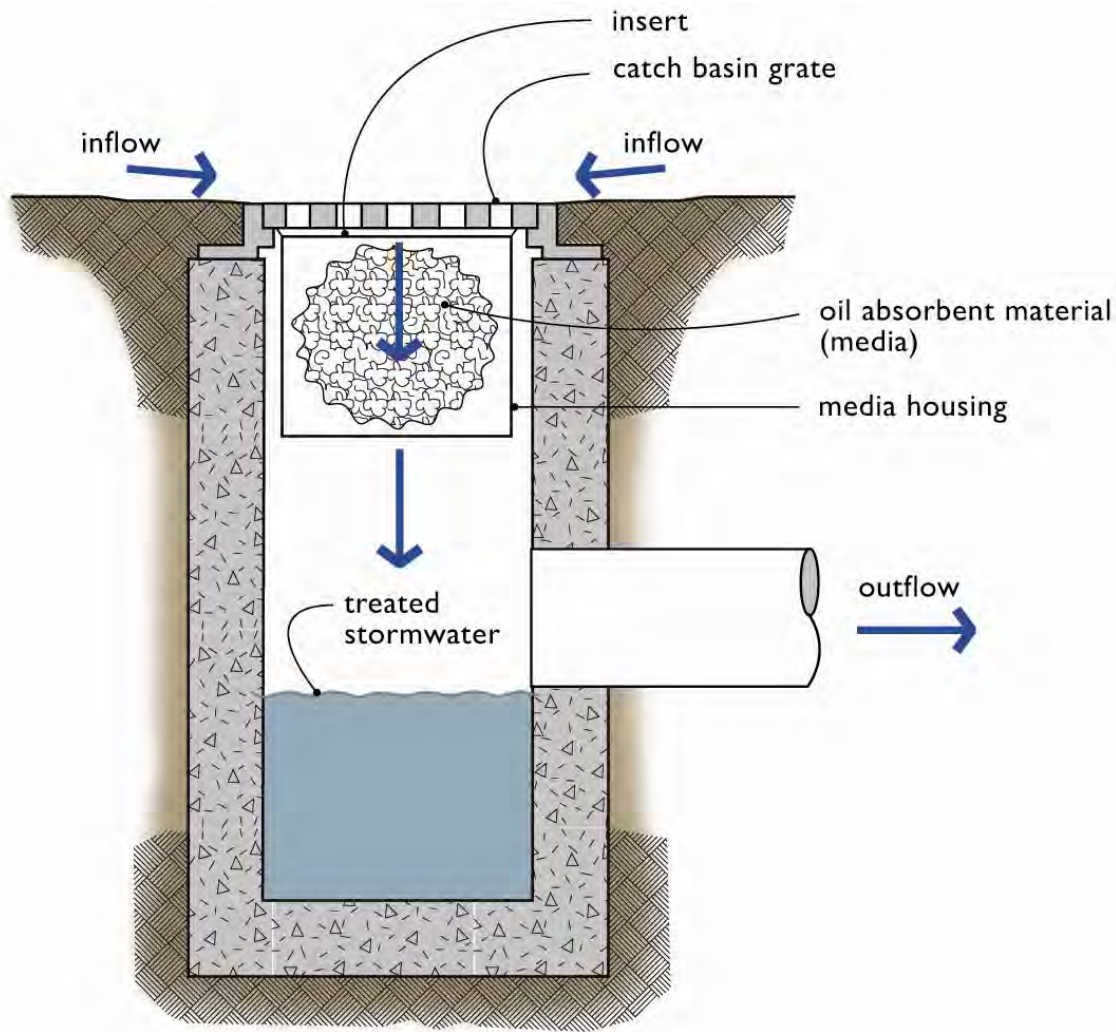
Catch basin inserts typically consist of the following components:

- A structure (screened box, brackets, etc.) which contains a pollutant removal medium
- A means of suspending the structure in a catch basin
- A filter medium such as sand, carbon, fabric, etc.
- A primary inlet and outlet for the stormwater
- A secondary outlet for bypassing flows that exceed design flow

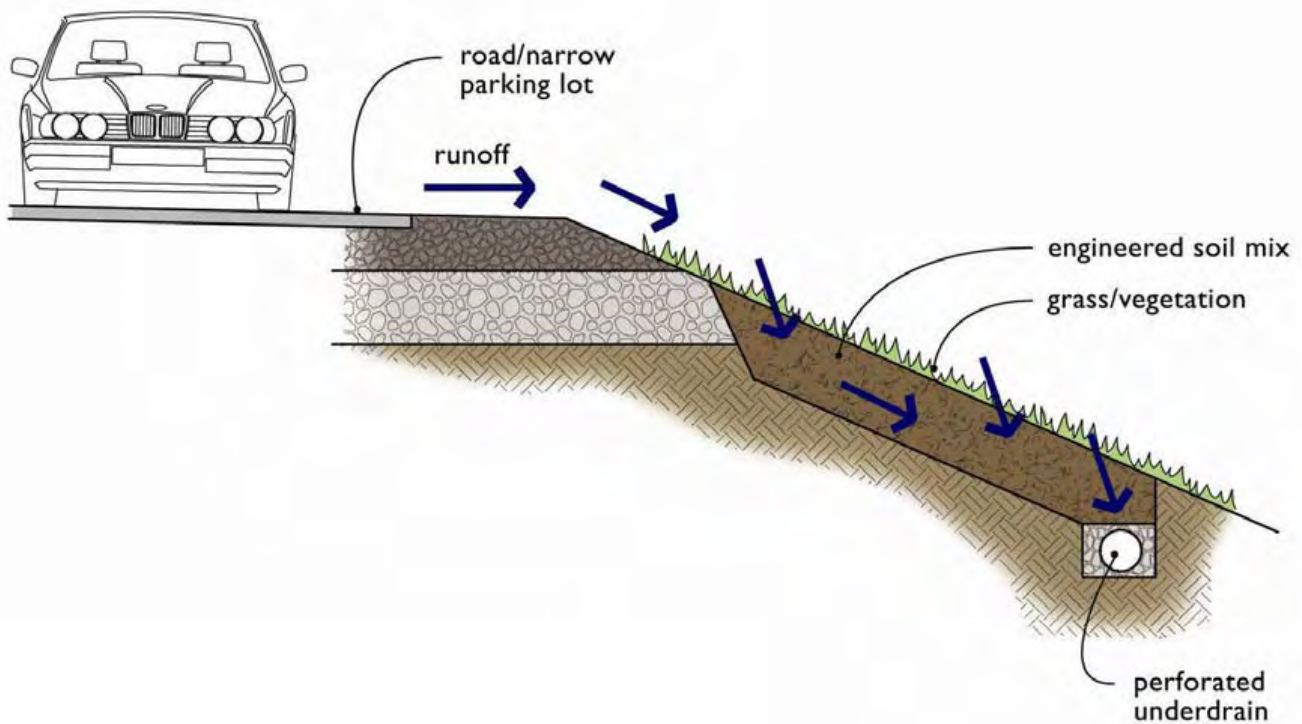
Facility objects that are often associated with an ecology embankment include:

- access road or easement
- fence, gate, and water quality sign

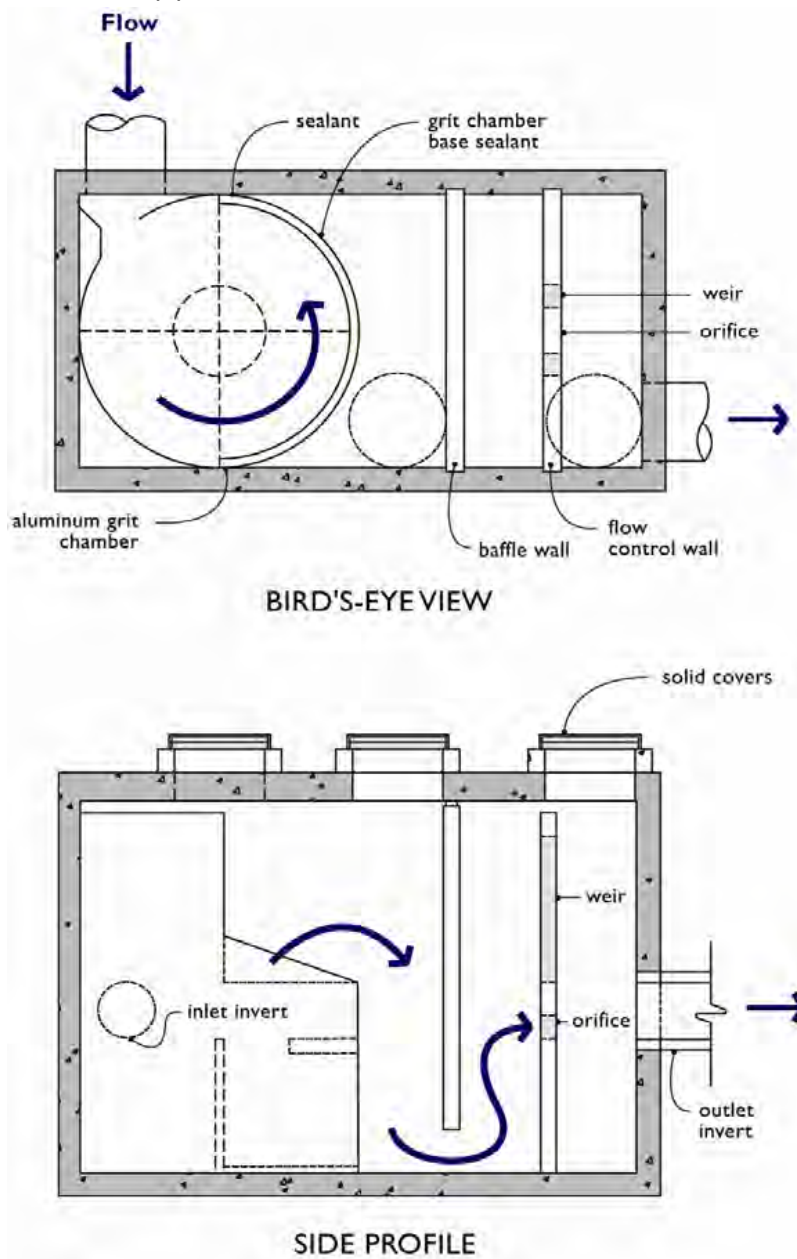
Facility objects that are often associated with a Vortechs® system include:

- access road or easement
- fence, gate, and water quality sign
- control structure/flow restrictor
- stormfilter
- inlet/outlet stormwater pipe
